Cooperative Research Centre for Coastal Zone, Estuary & Waterway Management

Technical Report 61

Noosa River entrance channel dynamics

**Steven Chamberlain
Rodger Tomlinson**

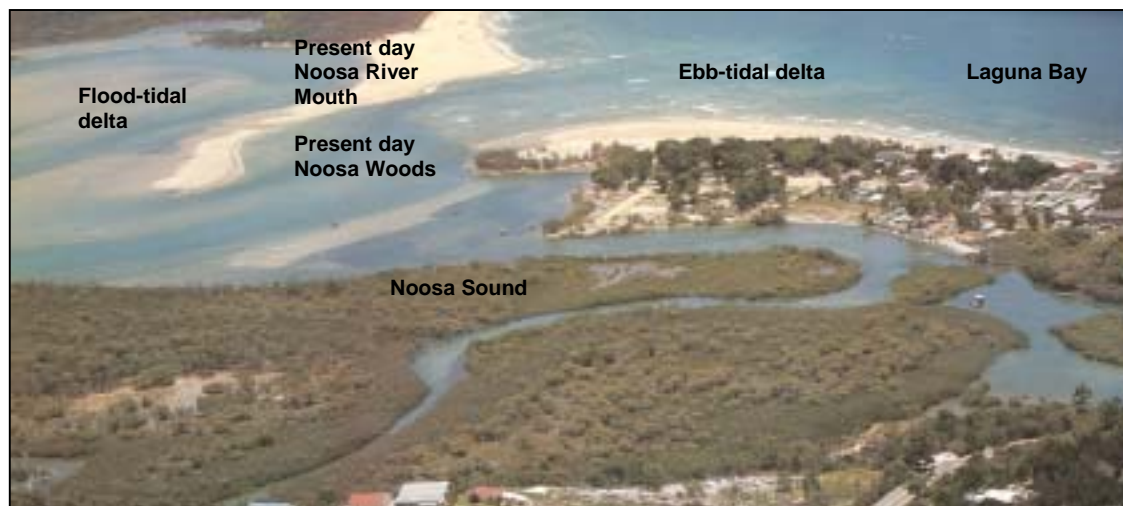
Figure 4. The Noosa River entrance in the 1960s (Source unknown)

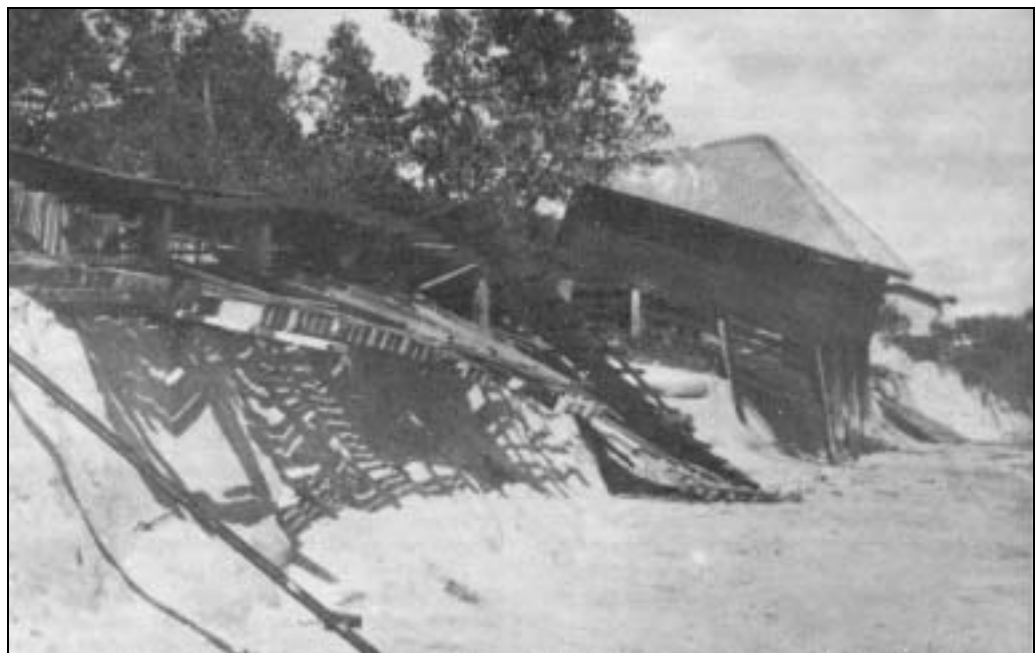
The storm induced erosion extended to within the property boundaries on Hastings Street, and flooding of the estuary resulted in the channel breaking through in a more easterly position and flowing directly to the sea (Jackson, Black & Tomlinson, 1999). Figure 5 indicates the extent of erosion, showing the dressing sheds on Hastings Street falling into the sea as a result of the 1947–48 cyclones (Cato, 1989). From the available information, it can be concluded that the beach and estuary system was relatively stable prior to 1967.

Figure 5. Dressing sheds on Main Beach falling into the sea as a result of the 1947–48 cyclones (Source unknown)

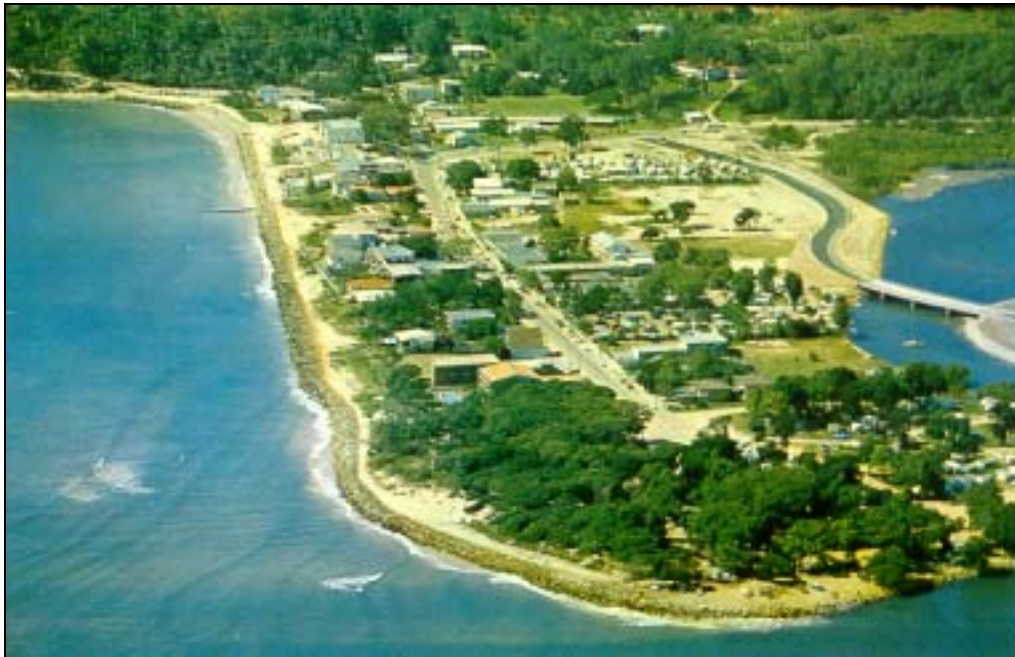
With an increase in property development occurring along Hastings Street, the major storm events of 1967–68 proved to be the catalyst for construction of the rock wall along Main Beach. Initially, the individual rock walls were made by property owners. This was later extended by the Noosa Council to cover the whole length of the beach, as shown in Figure 6. Although it provided protection

for beachfront properties it failed to address the locals concerns over erosion and the beach remained unusable at high tide (Cato, 1989).

Figure 6. The rock wall in 1972-73 after it was extended the entire length of the beach (Source unknown)

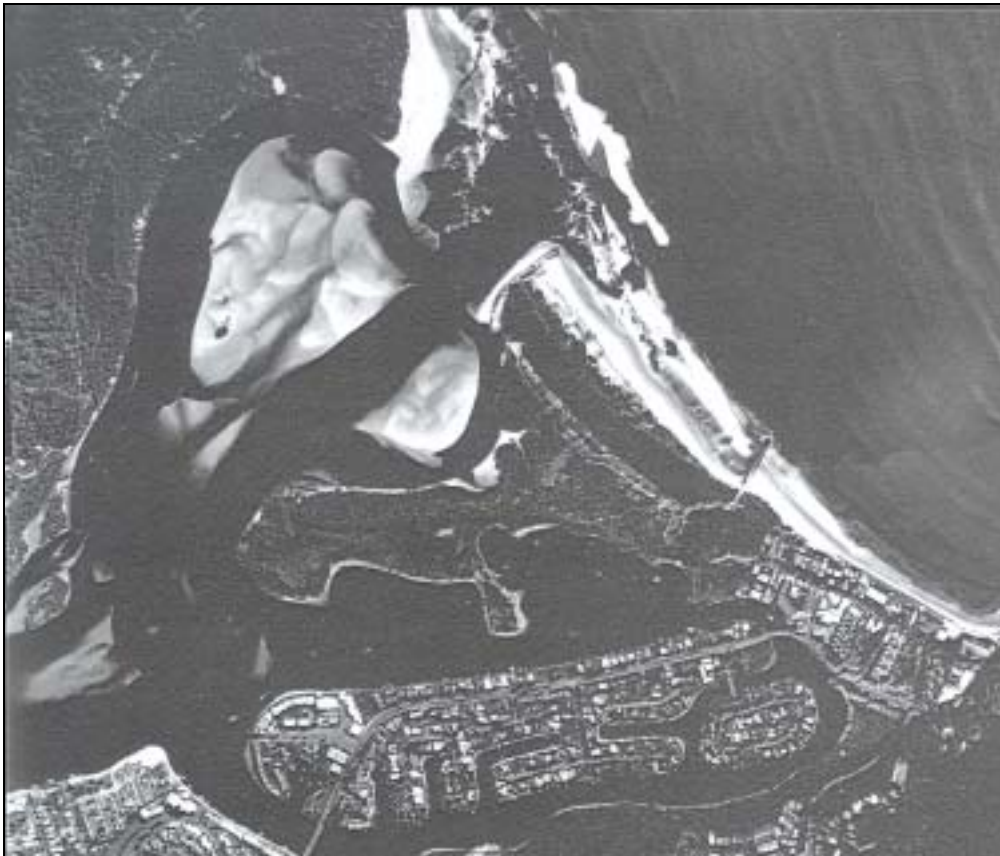
Both the northern and southern channels are open, but the dominant flow path is a 'middle' channel that cuts through the flood-tidal delta and flows directly to the sea. This direct flow path is typical of a flood/storm event and resulted as a response of the river to cyclones Betsy and Fran in January and March 1992, respectively. Figure 7 highlights the response of the system to a flood event. Cyclone Betsy resulted in a breakthrough of the southern channel and has effectively removed the cutback effect/meandering into Noosa Woods. This new 'middle' channel has all but removed the southern spit formation.

Figure 7. Aerial photograph of the beach and estuary system highlighting the response to a flood event in 1992

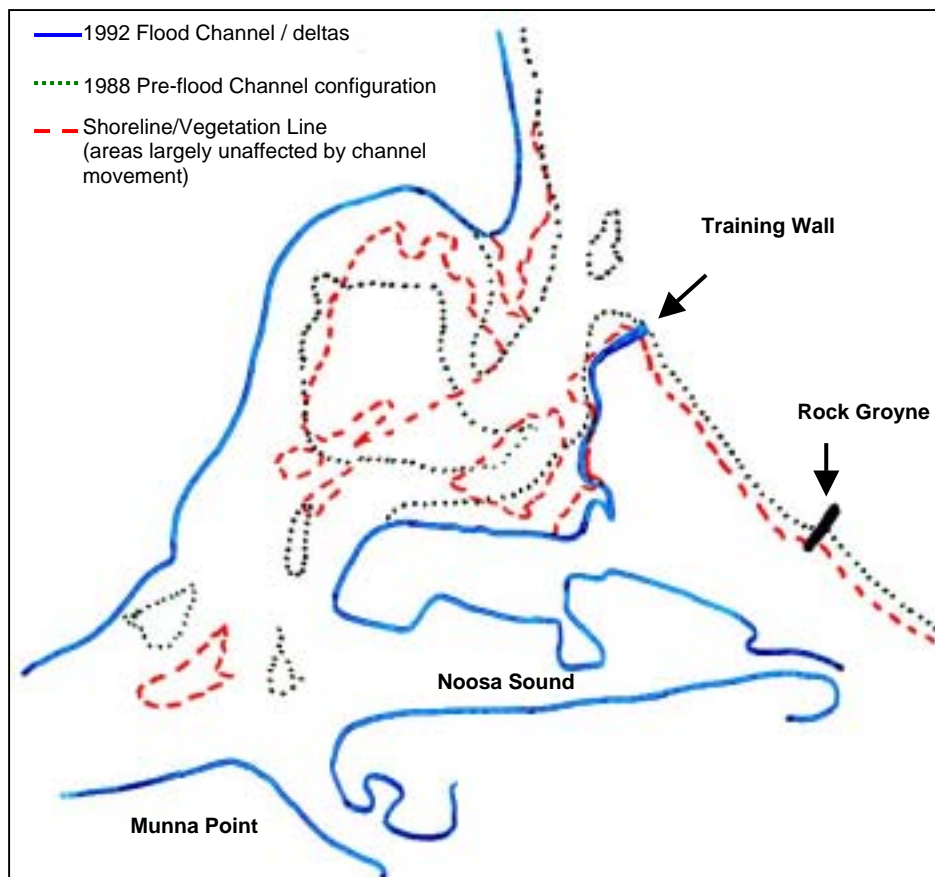
In recent times, the typical response of the system to flood events has been the formation of a middle channel that cuts through the dominant flood-tidal shoal and flows directly to the sea. Figure 8 indicates the location of the flood channel formed in 1992 and compares it with the pre-flood configuration of 1988. The recovery period generally results in the dominant middle channel reverting to the more characteristic meandering southern channel.

Figure 8. Overlay of Noosa Beach and estuary system indicating the response to storm events

As conditions return to normal, flood tides begin transporting sand through the inlet. At low tides, the flow is restricted to the channel so sediments are transported further up the estuary towards Munna Point. However, at higher tidal elevations, the deltas are covered and sheet flow occurs. This corresponds with a slower flow velocity and hence an opportunity for sediments to settle on the deltas. As the northern spit enlarges, it forces flow over remnants of the dominant flood-tidal delta. This results in growth of this delta and the delta on the southern side. These two features generally result in the deflection of flow towards the Noosa Woods area as the previously dominant middle channel becomes constricted.

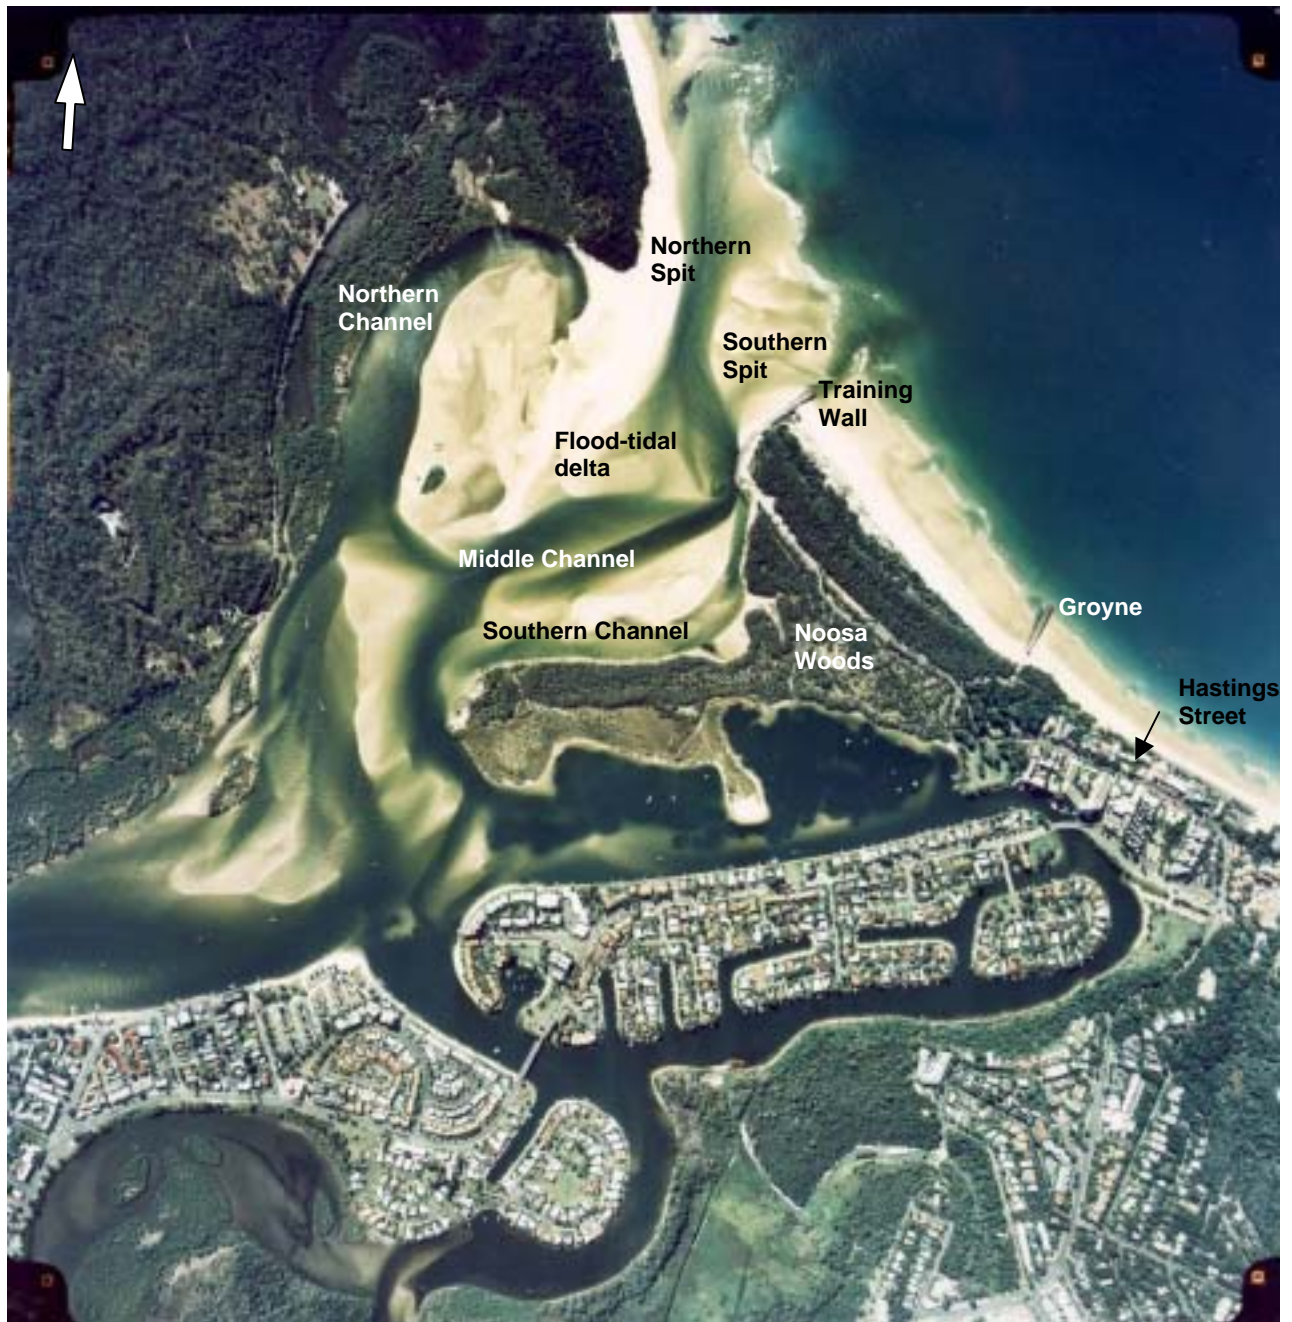
Figure 34. Noosa beach and estuary system, 25 May 1994
(Source: Beach Protection Aerial Photography, 1994)

The photo taken in May 1994 (Appendix 1, Figure 34) again shows the inlet to be in an unstable northerly orientation. As previously mentioned, the excess sand responsible for this channel migration would have been due to cyclones Fran and Betsy in 1992. These events would have been responsible for transporting large 'slugs' of sand around the headland into Laguna Bay, before smaller swells transported the material back onto the beach under normal conditions.
